STRUCTURAL ASSESSMENT

West Appliance Building

327 Main Street

November 17, 2018

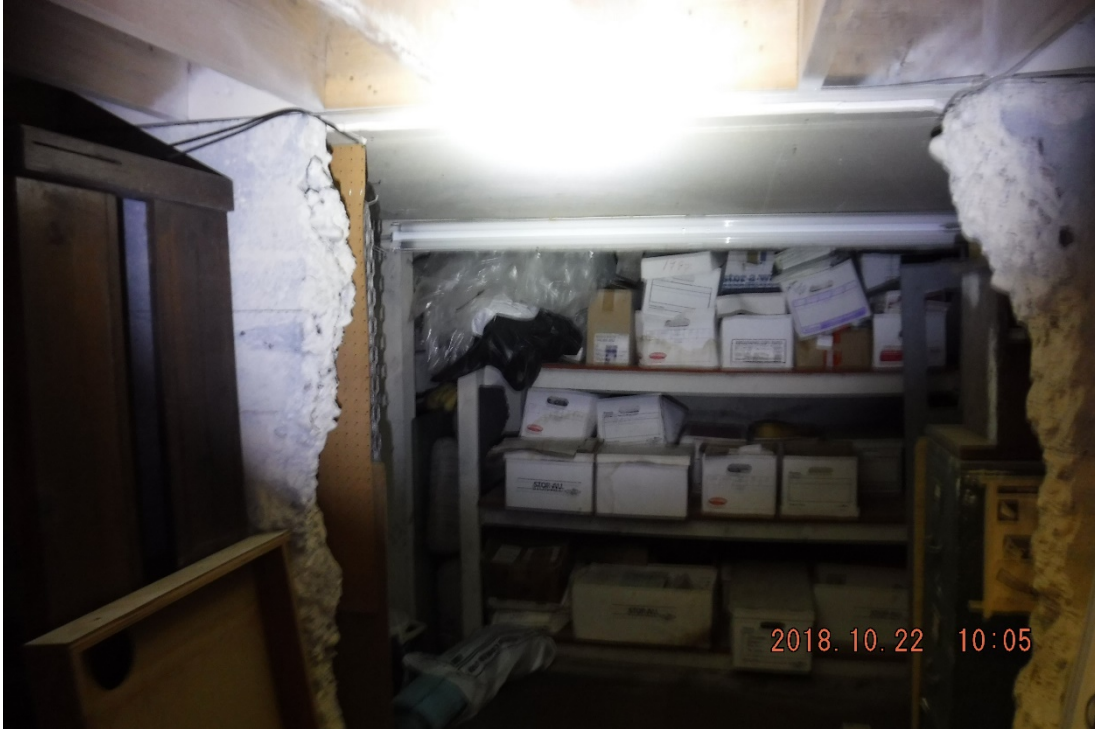
Two access doorways have been created in the basement middle wall, along gridline 5. The opening to the west, nearest gridline A, appears to have been created at the time of the basement wall construction. The opening to the east, nearest gridline B, appears to have been "knocked" out later. The floor joist above the openings are supported by wooden beams. However, these beams do not appear to have satisfactory end bearing.

Photo 3 - Basement Opening

It is recommended, that the main floor system above the two openings be shored to provide support. It is recommended that “Do Not Enter” tape or other warning signs be placed across the crawlspace access or the crawl space access blocked. Additionally, it is recommended that periodically review the basement walls and floor joist for movement or structural destabilization occur during the remediation of the structure.

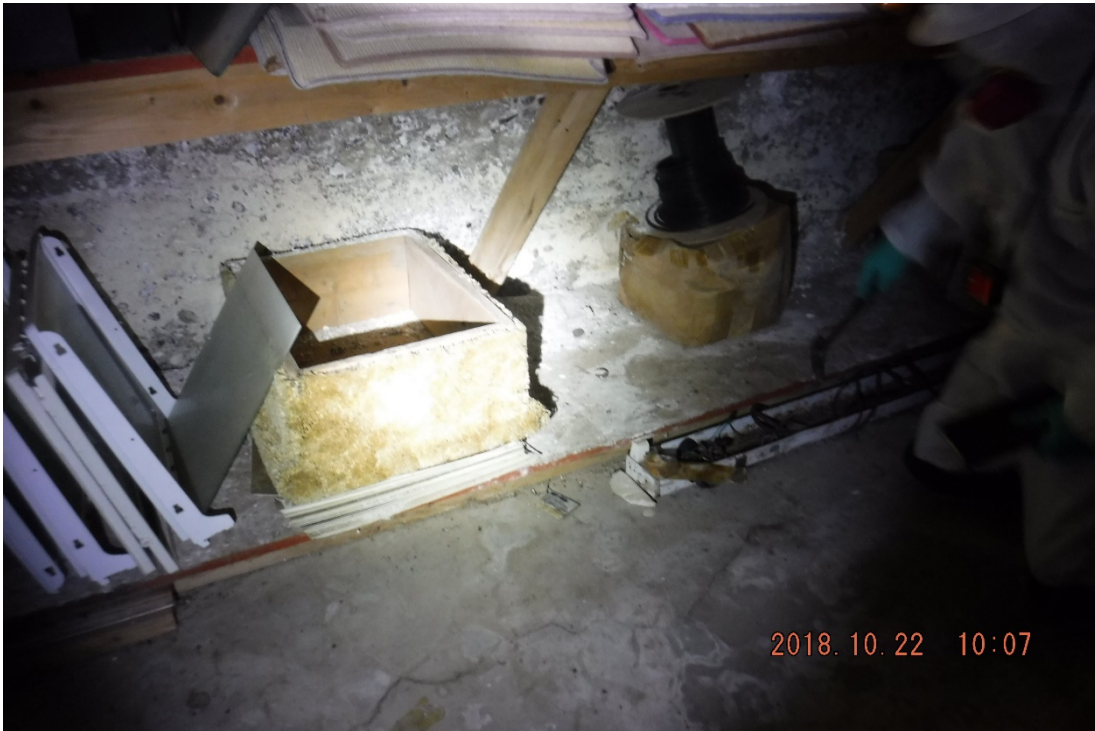
The only found basement is in the south west corner of the building on lot 7. The basement is accessed by a stairway located just to the right upon entering the back doors. The basement is divided into two cells by a middle running concrete wall, along gridline 5. The basement walls appear to be cast in place concrete foundation walls. The foundation below these walls are not visible. No signs of rotation or stabilization concerns were noticed in the basement. Sounding of the walls indicate that the concrete is generally solid. However, the bottom of the walls and other isolated areas are showing signs of concrete decay with delamination and spalling occurring.

Photo 4 - Basement Wall Deterioration

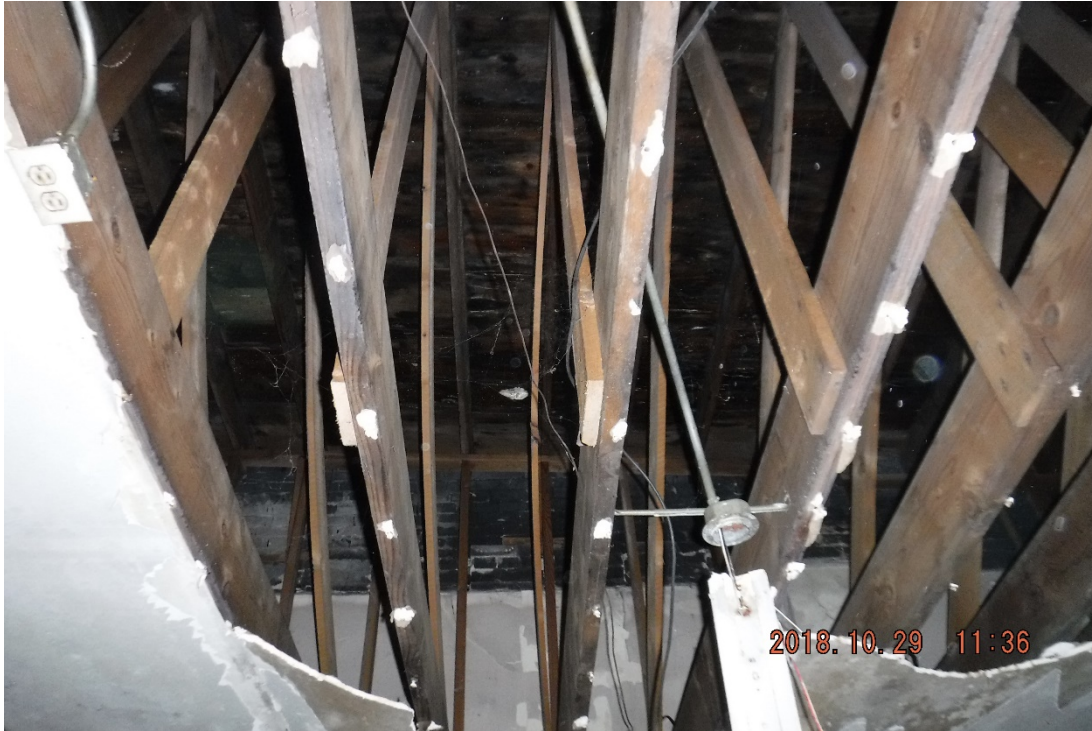
The main floor for the building contained on lot 7 is defined by the area outlined by gridline A, D, 3 and 6 and is denoted as area M1. This area appears to have undergone significant water damage. The floor system is wooden joist and decking. While not visible, indications are that the floor members structural capacity has decreased. Walls on the main floor system of the M1 area is covered but appear to be stable. The roof system in this area is comprised of hand-built trusses and wood bracing. The roof in the M1 area appears to have undergone significant water damage. The web members of the trusses are bowing, which may be due to overstressing or lack of bracing. Preliminary indications are that the roof system in the M1 area is not adequate to support the roof and roof loading.

Photo 5 - Truss Bowing Area M1

It is recommended that the roof system be shored prior to allowing removal of any material from the roof or inside of the building. As punching through the floor system is a concern, roof shoring may not bear on the floor system unless adequate bearing can be verified. As removal of material may result in unloading of the walls, bracing is recommended as a preventative measure. As with the roof system, it is advisable that wall bracing not to bear on the floor system unless the bearing can be verified.

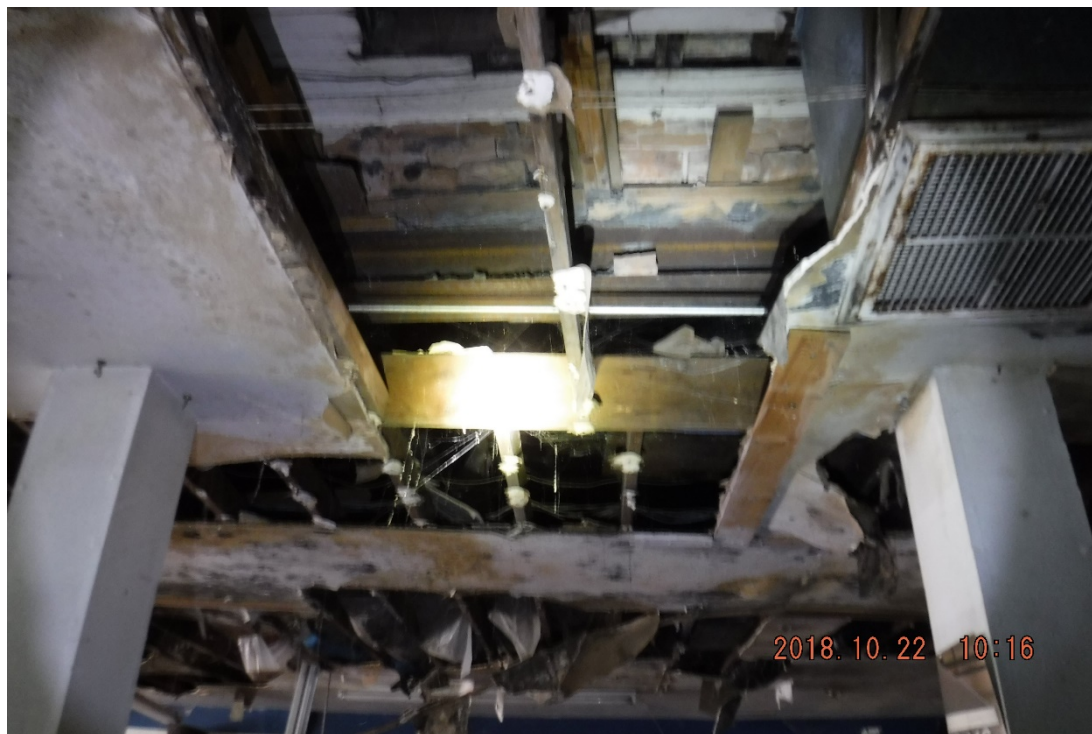
on gridline 3. The Beam B appears to have been installed when the masonry wall separating Lot 6 from Lot 7 was removed. Both Beams A & B appear to be intact and show no signs of structural distress. Both beams are supported by steel columns. The supporting steel columns for Beam A bear on concrete footings constructed upon the subgrade material in the crawl space. The supporting steel columns for Beam B bear on concrete leveling pad placed/formed over the stone foundation. The concrete for the all columns is deteriorating and it is not possible to determine if the concrete is reinforced.

Photo 6 - Steel Beam A & Wood Framing

While the ceiling-2nd floor above the main floor, lot 6 original, appear to be stable, indications are that the wood contained within the 2nd floor system has seen water damage and thus a reduction in structural capacity is likely. It is recommended that the walls and steel beams (Beam A & B) be braced and that due to significant water damage, the bracing not bear on the main floor system. Additionally, localized areas of destabilized in the ceiling and 2nd floor system may become apparent during remediation and if identified, shoring installed and previous.

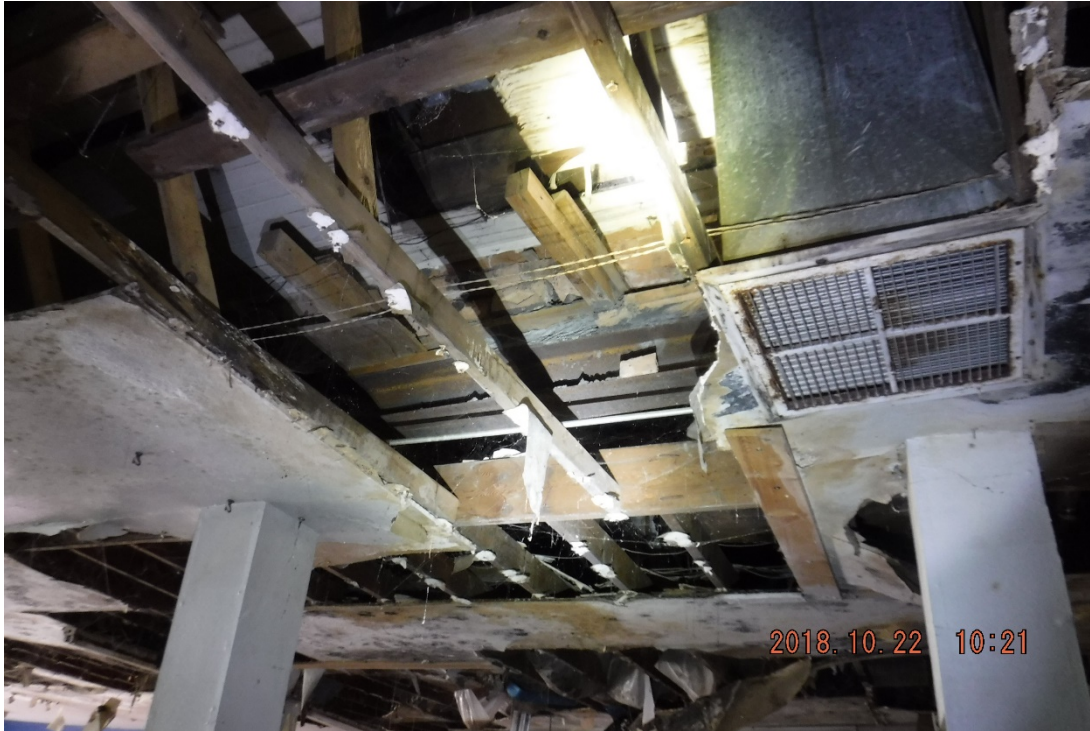
Photo 7 - Steel Beam B & Wood Framing

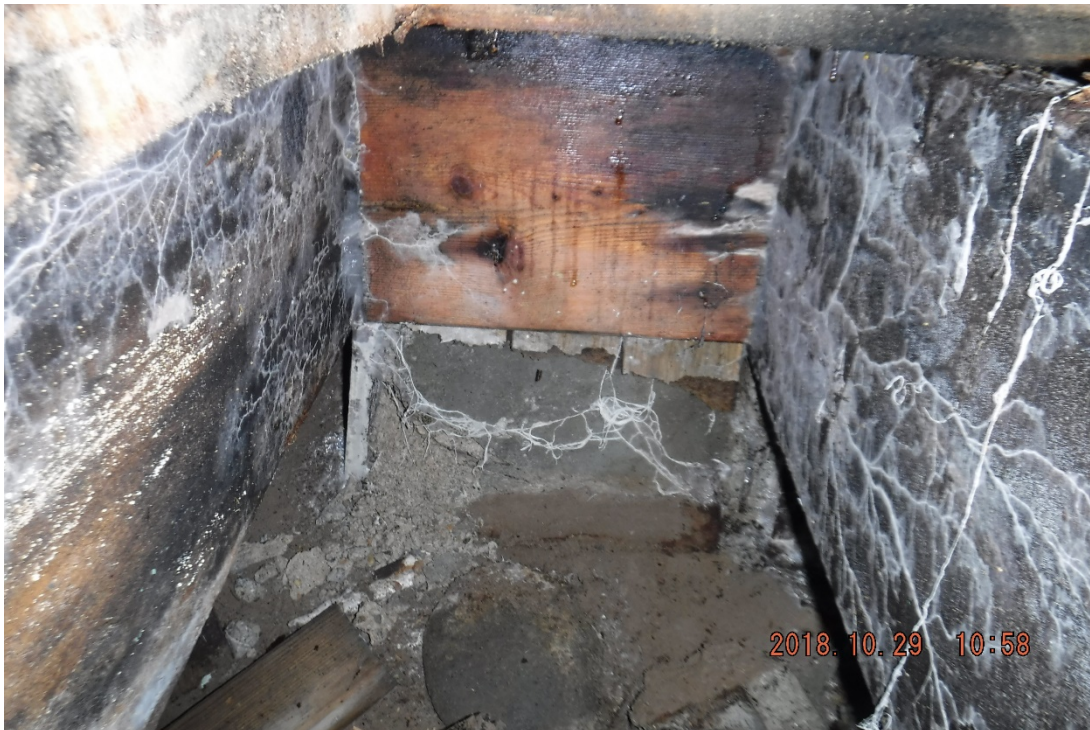
Photo 8 - Concrete Footing Below Beam A

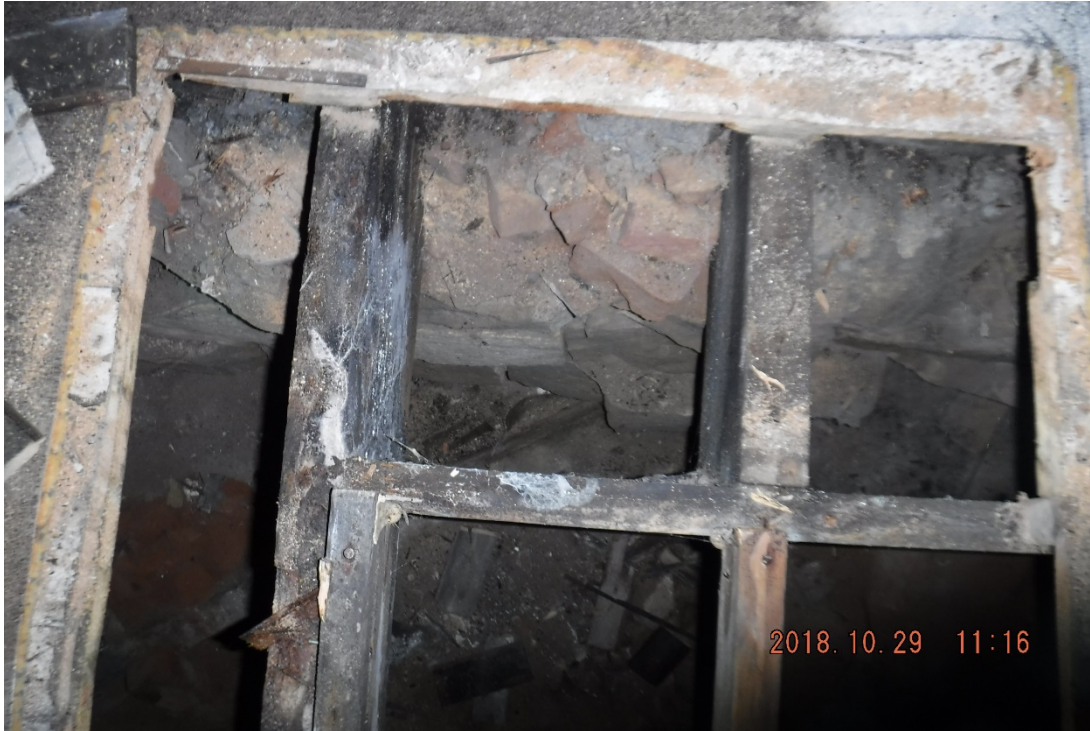
Photo 9 - Stone Foundation Below Beam B

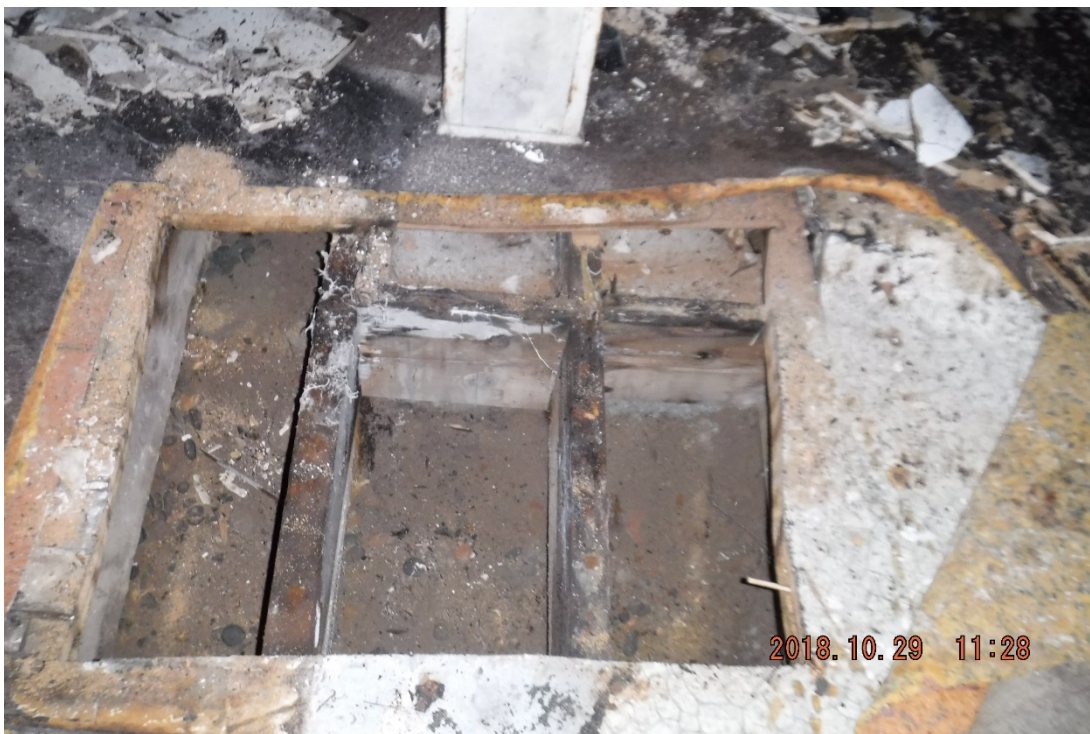
The main floor for the original building contained on lot 6, is defined by the area outlined by gridlines C, D, 1 and 3. The floor system in this area has seen significant water damage. The flooring is buckling due to moisture swell. Observations indicate that the floor joists in this area have experienced both fire and water/moisture damage and thus have undergone a reduction in structural capacity. The north and east sides of the M2 area are covered but appear to be stable. The ceiling and 2nd floor system is supported by both a steel beam (Beam A) centered on gridline 2 and wood. The ceiling and 2nd floor system is supported at the ends by the masonry exterior wall along gridline 1 and a steel beam (Beam B) centered

Photo 10 - Water Damaged Floor Joist Area M2

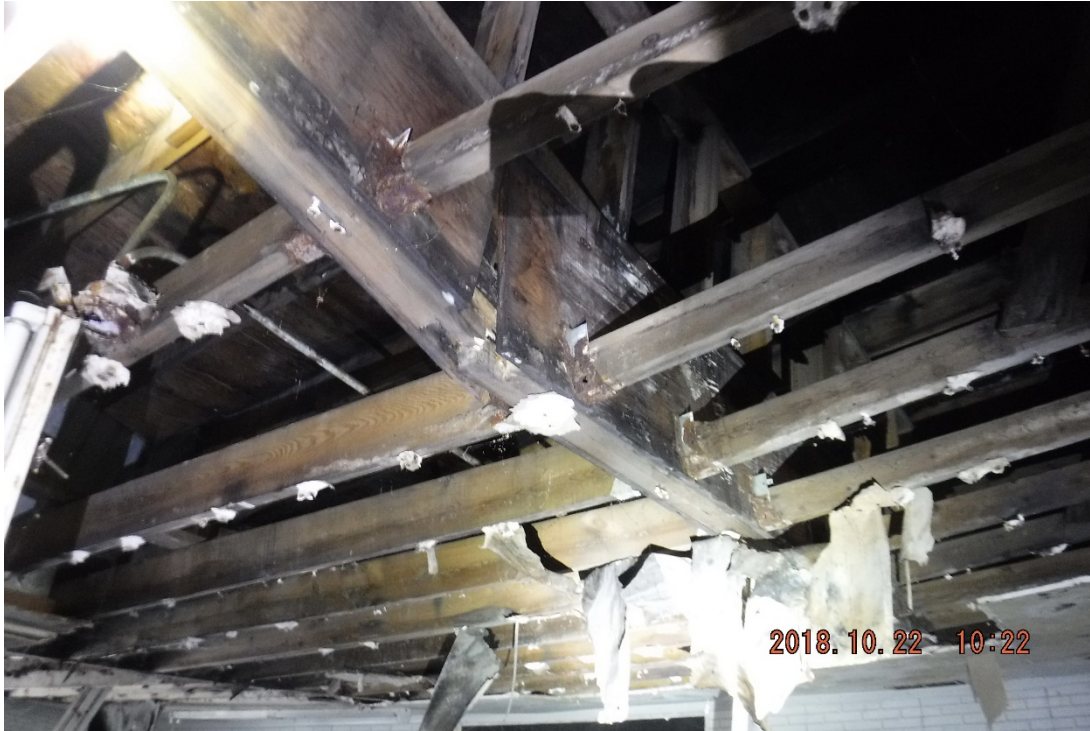
The area added to the original building is defined by gridlines A, C, 1 and 3. The floor system in this area appears to be a concrete slab. Sounding of the slab indicates that the slab is solid. However, based on the overall structural integrity of the building, deterioration of the slab may have occurred. The bearing walls along gridlines A, 1 are covered but appear to be stable. However, note that at the intersection of gridlines C and 1, the brick is deteriorating. The ceiling and roof in this area has seen significant structural damage and is comprised of several broken wooden members.

Photo 11 - Broken Structural Member Area M3

It is recommended that the M3 ceiling area as described above be fully shored prior to beginning any removal or shoring activities within the entirety of the project. It is recommended that steel shoring be utilized and that the shoring bear on the concrete slab. However, the concrete may have undergone deterioration and it is advisable that an assumed compressive strength of less than 2,500 pounds per square inch be utilized, unless the strength is otherwise verified by testing. In addition to the ceiling/roof shoring, it is recommended that the 2nd floor wall that runs along gridline C also be shored utilizing a steel frame system. In addition to shoring the ceiling/roof and 2nd floor wall, the exterior walls, it is advisable

that the walls be braced. Bracing may be attached to the concrete floor with the same limitations to the compressive strength as previously discussed.

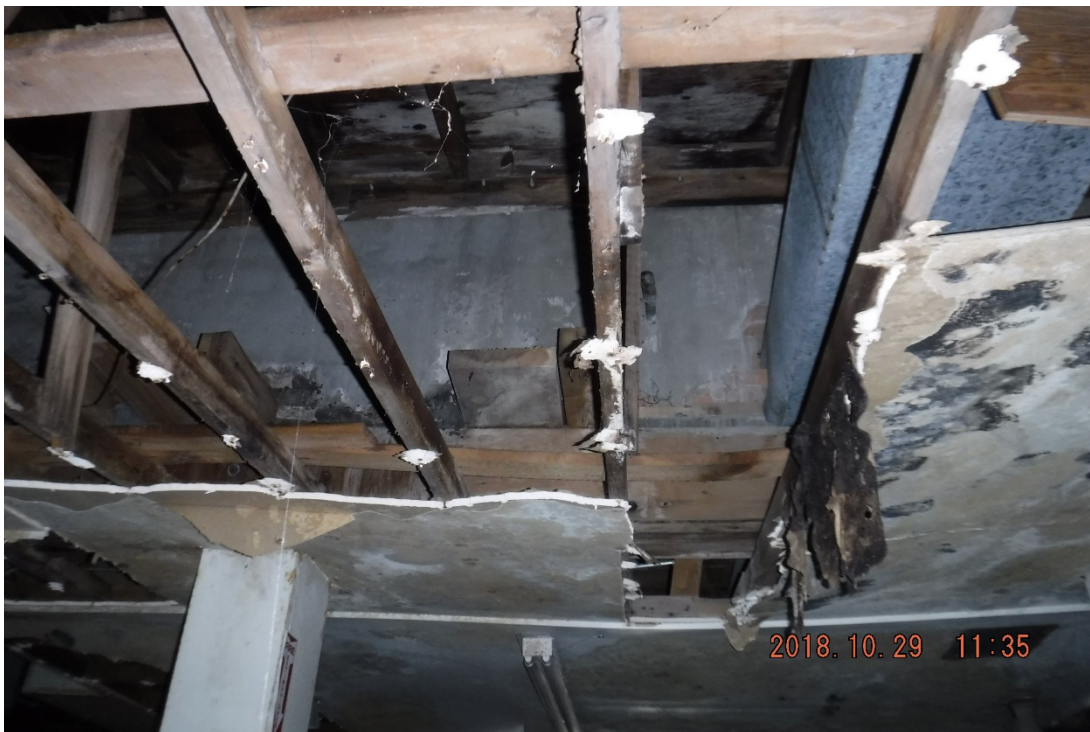
Photo 12 - Damaged Support Below Masonry Wall Above Gridline C

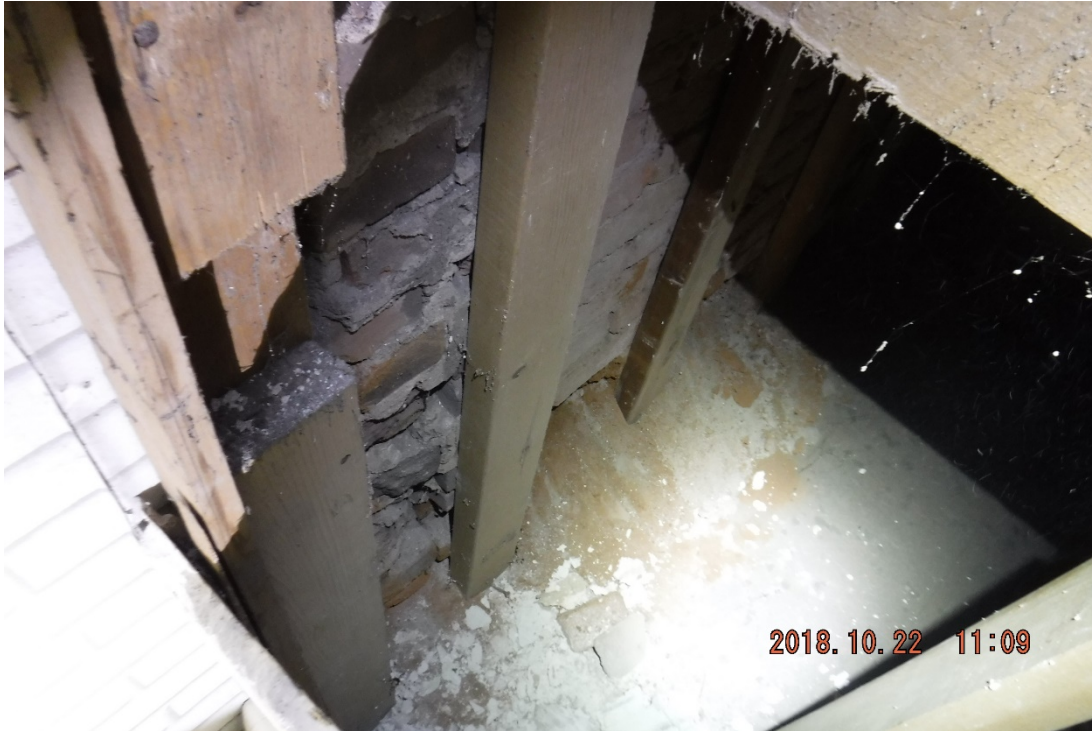
Photo 13 - Deteriorating Masonry At Gridline C

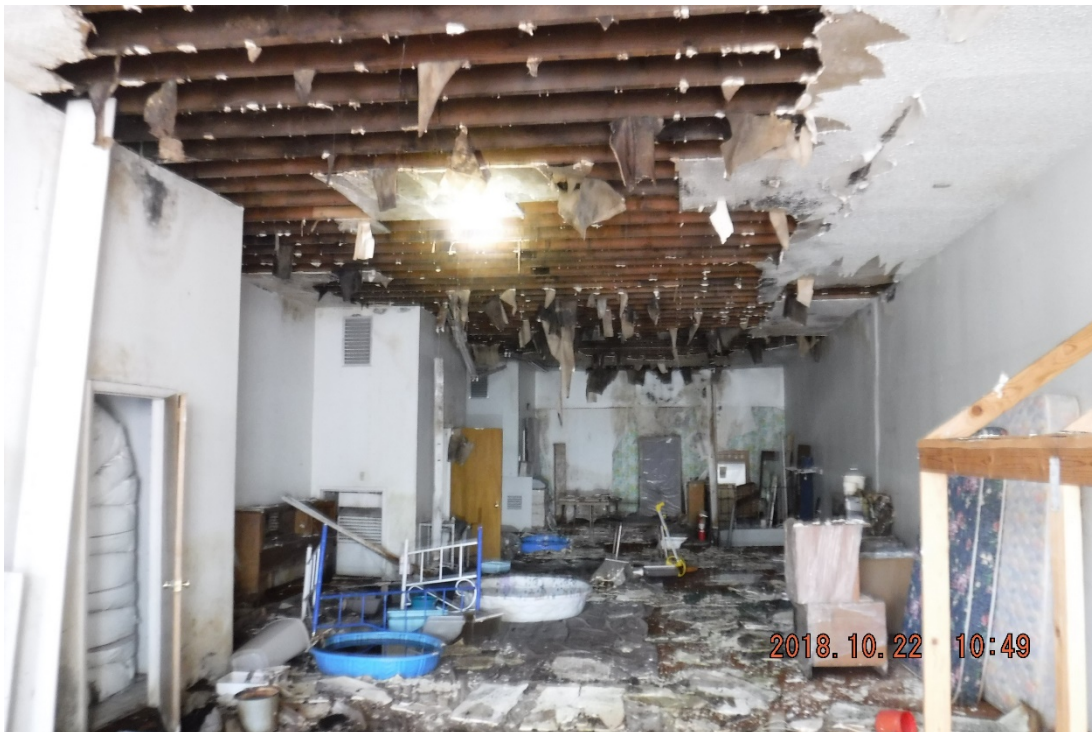
The second-floor area of the building contained on lot 6 is described as the 2nd floor area outlined by gridlines C, D, 1 and 3. This area generally appears to be stable. The floor system as seen from area M2, below, is comprised of wooden and steel members. The floor system appears to be stable, however, signs of water damage may indicate a reduced structural capacity. The walls appear to be stable with no significant signs of rotation. However, tension ties have been placed along gridline C and indicate possible past movement or instability within the wall. The ceiling and roof in the S1 area appears to be stable and adequate to carry the existing loads. However, water damage is evident and as such unseen members or areas may have reduced structural capacities due to water damage.

Photo 14 - Water Damage Area S1

The S1 area appears to be stable for removal of material. Shoring is recommended in localized or areas of instability discovered. The bearing for the shoring may have to extend though the M2 area below and be founded on suitable subgrade in the crawlspace. The walls contained within the M2 area may require bracing as instabilities become apparent.

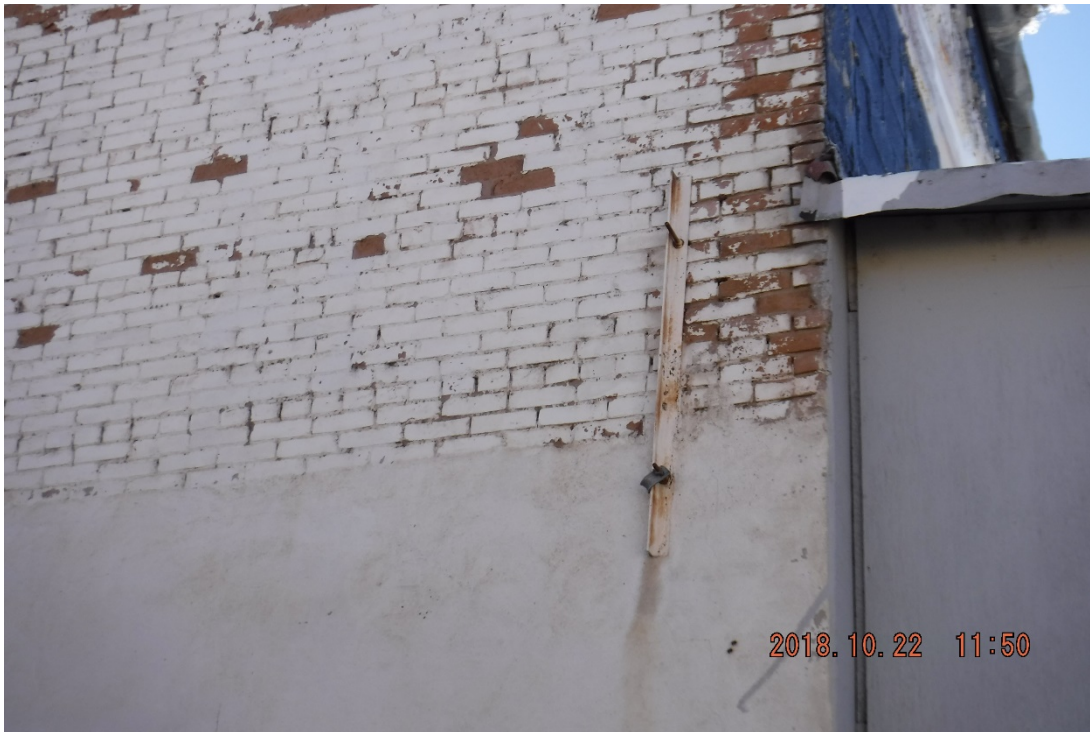
The initial review of the north exterior wall along, gridline 1, indicates that the outer bearing wall of the building is comprised of brick masonry units. The wall is a two-story wall with a parapet and extend from gridline C to D. The brick masonry is showing signs of cracking and tension ties are visible at the

Photo 15 - Tension Ties Intersection Gridline 1 & C

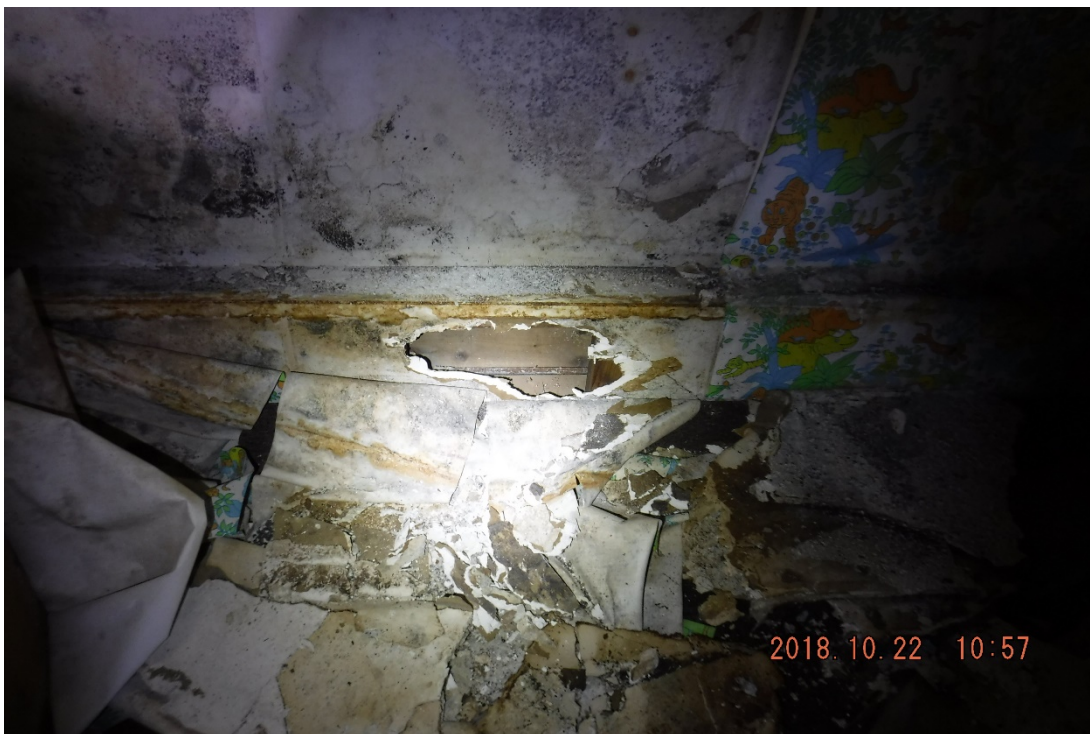
Photo 16 - Tension Tie In Wall Along Gridline C

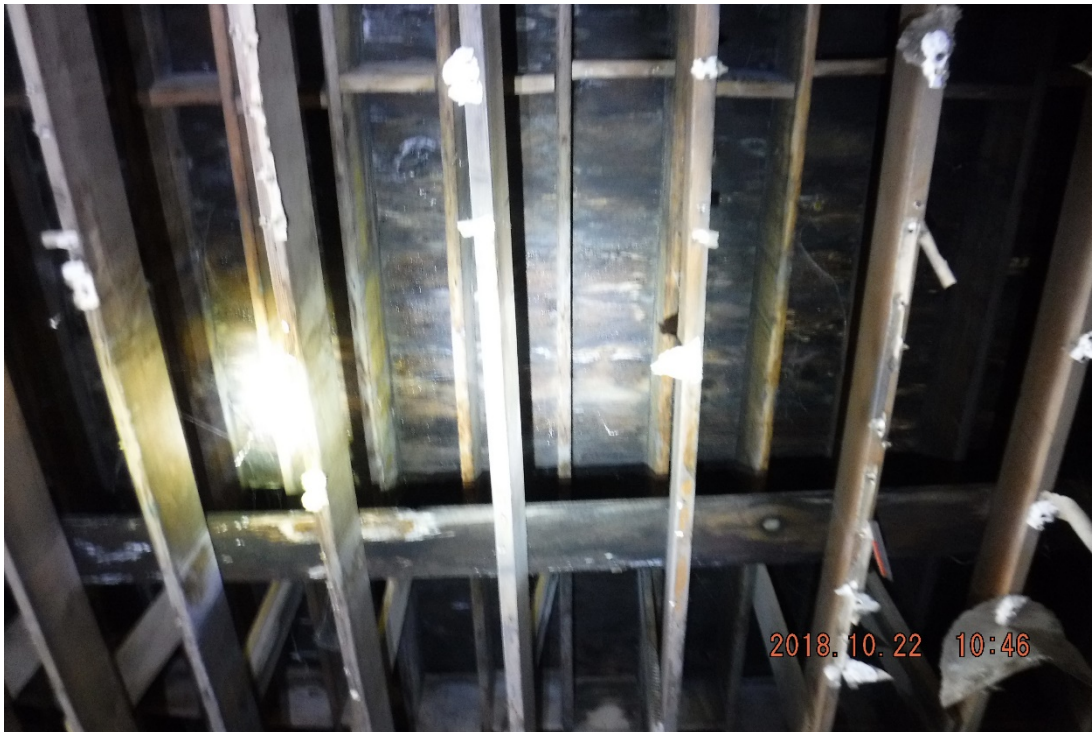
In general, the roof system for the building in its entirety has likely undergone significant water damage and as such decking and support members may have undergone significant decrease in structural capacity. It is recommended that shoring be provided from below as necessary along with a stable working platform. Care needs to be taken not to overload the existing roof system and shoring support have a direct load path to the crawl space subgrade. Bearing shoring on any floors or floor systems is not advisable, unless within the area of concrete slab or adequate bearing can be verified.

Photo 17 - Ceiling & Roof Water Damage Area S1
